NDI THROUGH HVOF COATINGS

20 FEB 02

Air Force Research Laboratory

13. SUPPLEMENTARY NOTES 20th Replacement of Hard Chrome Plating Program Review Meeting, February 20-21, 2002, Orlando, FL. Sponsored by SERDP/ESTCP.

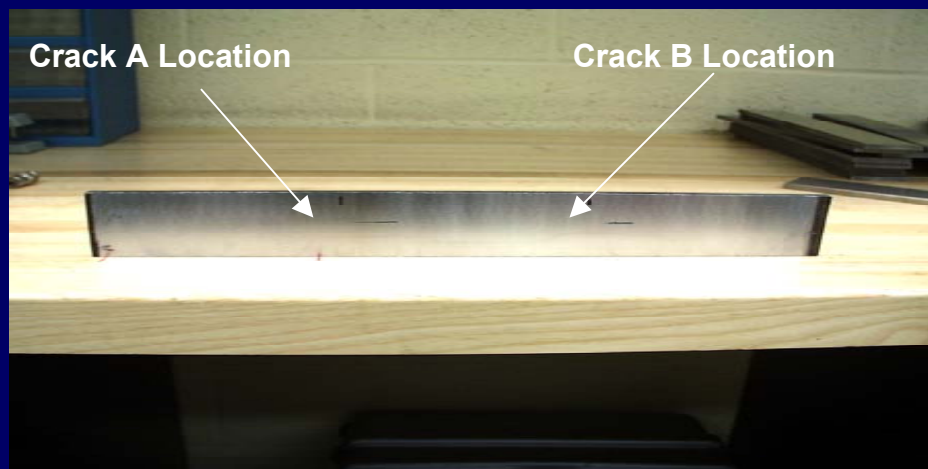
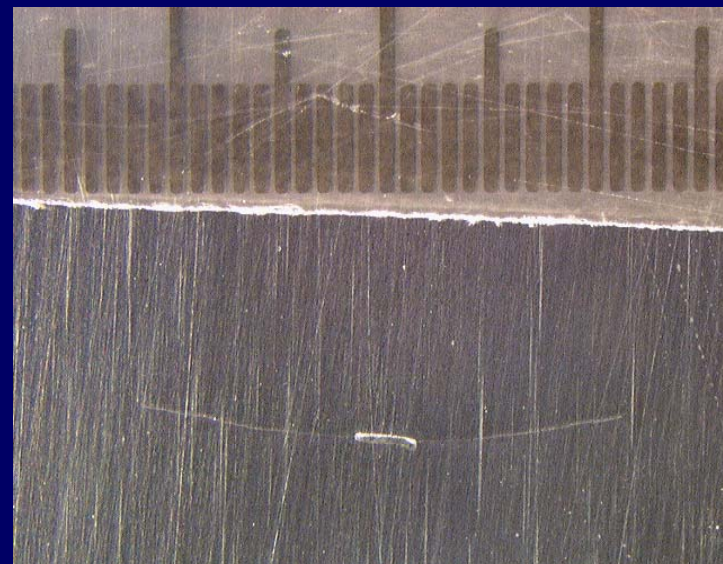
Specimens

- 38 flat plates of 4340 steel (initially uncoated)
- 0.30" thick, 2" wide, 14" long
- Each specimen had 2 starter EDM notches
- Mechanically grown cracks
- EDM notches machined off

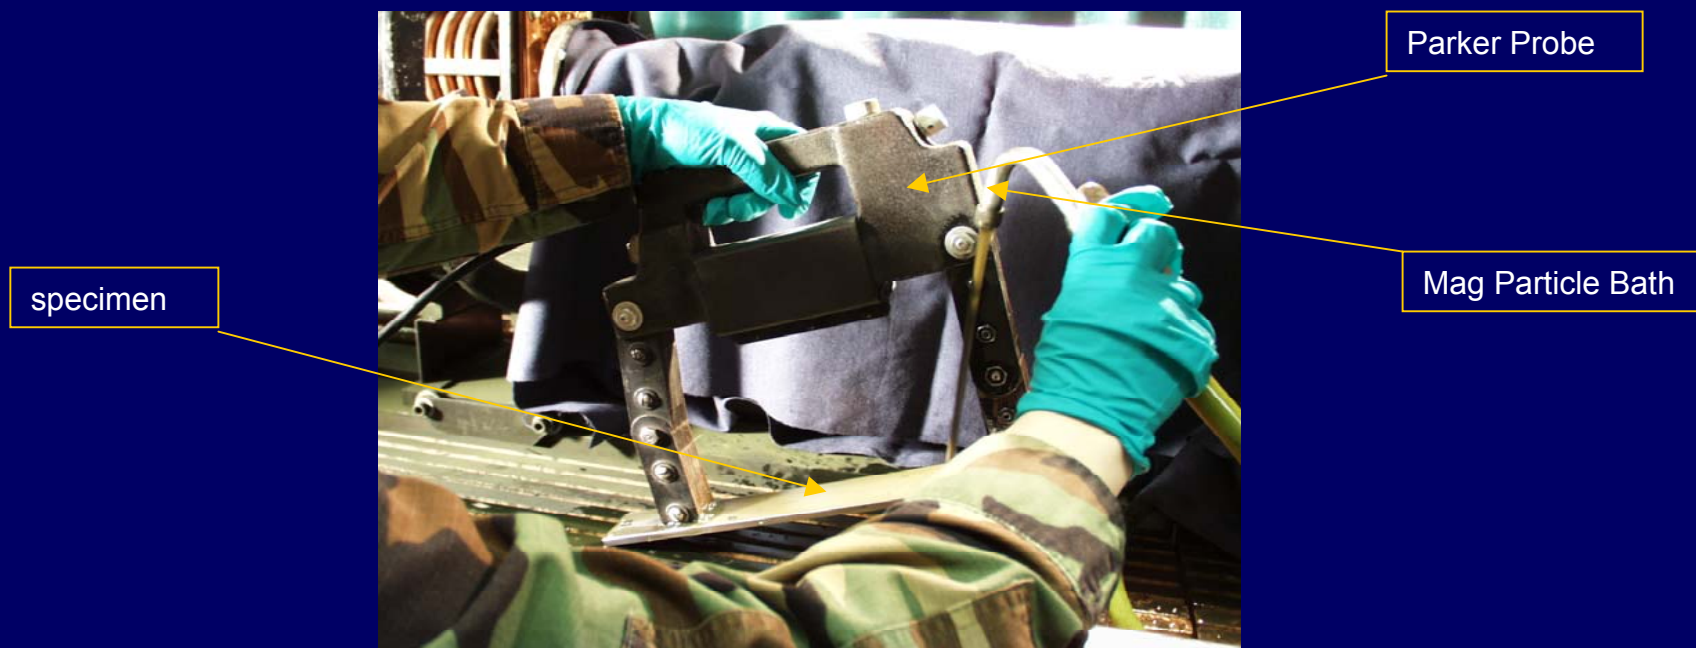
Magnetic Particle Inspection

- Inspection completed IAW ASTM E1444
- Used Parker Probe to magnetize specimens
- Probe set to highest AC power -- for best results
- Poured magnetic particle bath over specimen

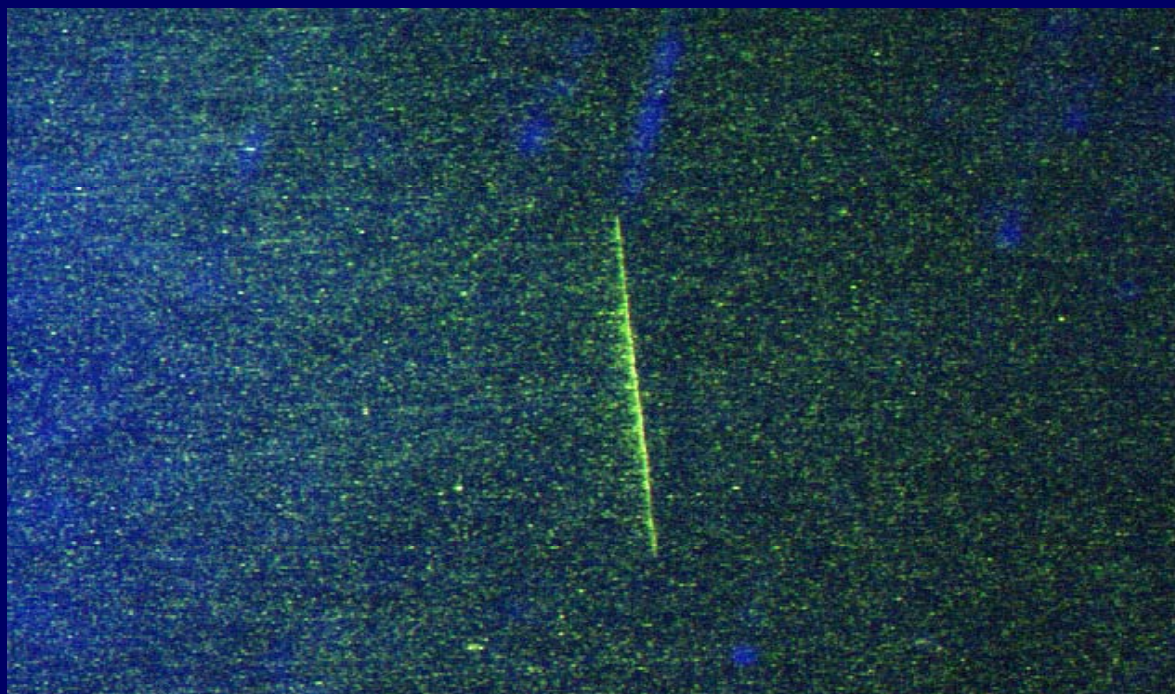
- Let the bath drain then examined specimen under an ultraviolet light

Uncoated Specimen Detected Crack 0.141 inch in length

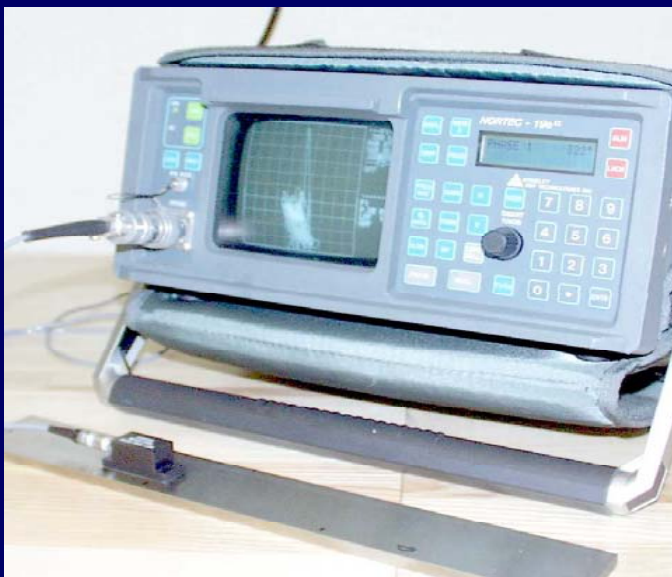
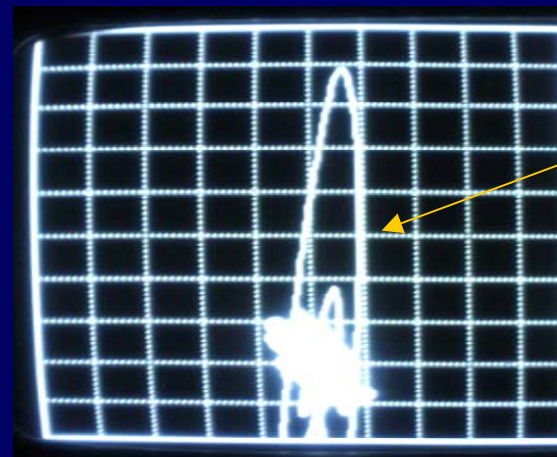
- Technique was developed with a Nortec 19e^{II} instrument and an absolute probe operating with a frequency of 100 kHz
- The probe was scanned by hand until crack signal was maximized

An eddy current response

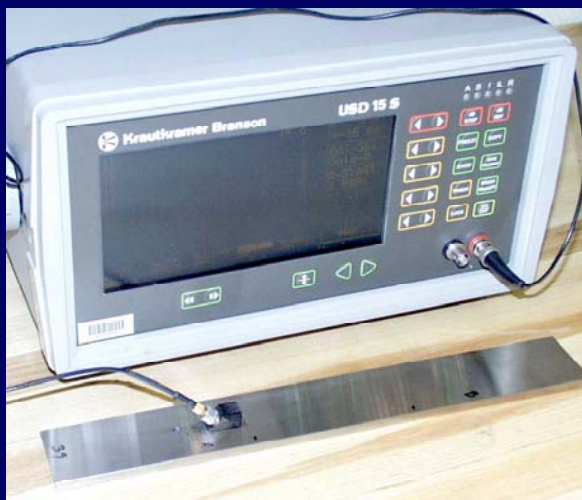
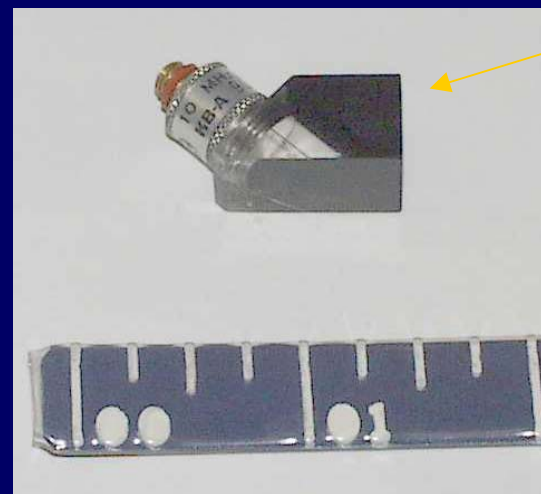
- A manual ultrasonic pulse-echo, shear-wave technique was developed with a Krautkramer Model 15S ultrasonic instrument and a 0.25 inch, 60 degree, shear wave, 10 MHz transducer

Transducer

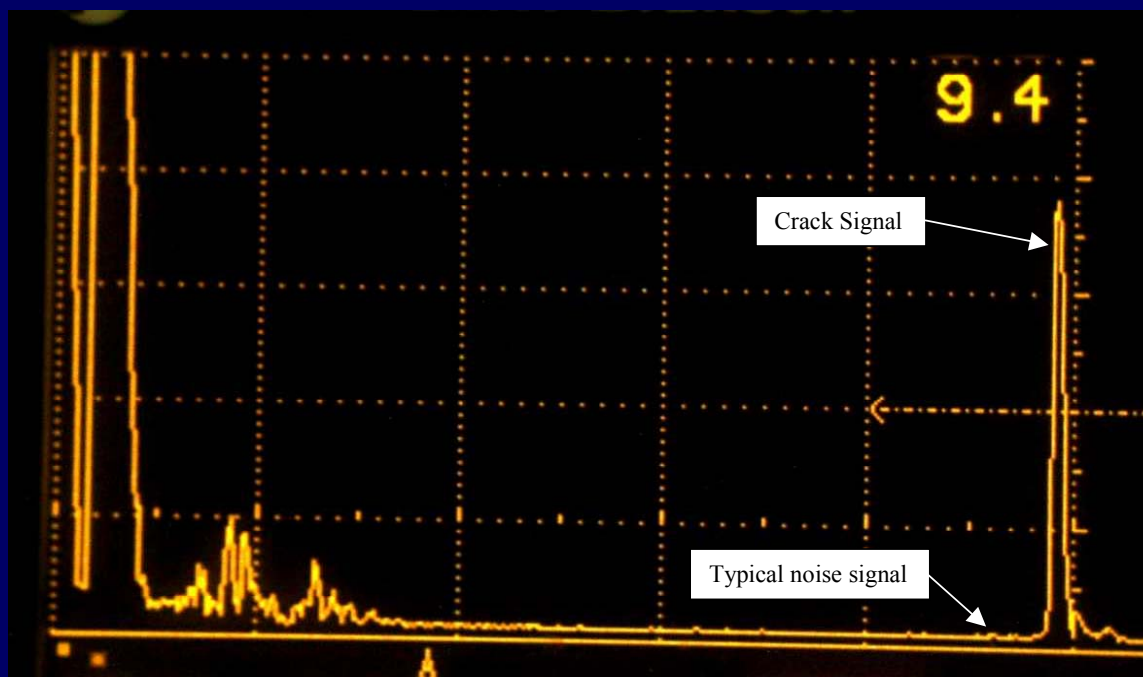
Ultrasonic Inspection (cont.)

- The transducer was placed on the same surface as the crack then manipulated by hand until the amplitude of the reflected signal was maximized
